S72 and S75 Structure Refurbishment

Project & Lands Committee
November 9, 2016

S72 & S75 Structure Refurbishment

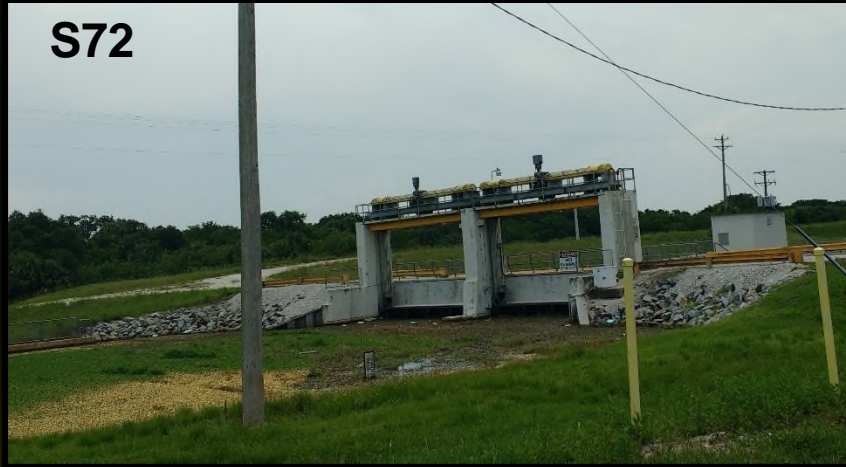
S72 Structure Details

- Built in 1960
- S72 structure is a reinforced concrete, gated spillway with discharge controlled by two (12'x28') vertical lift gates.
- Design discharge capacity: 3120cfs

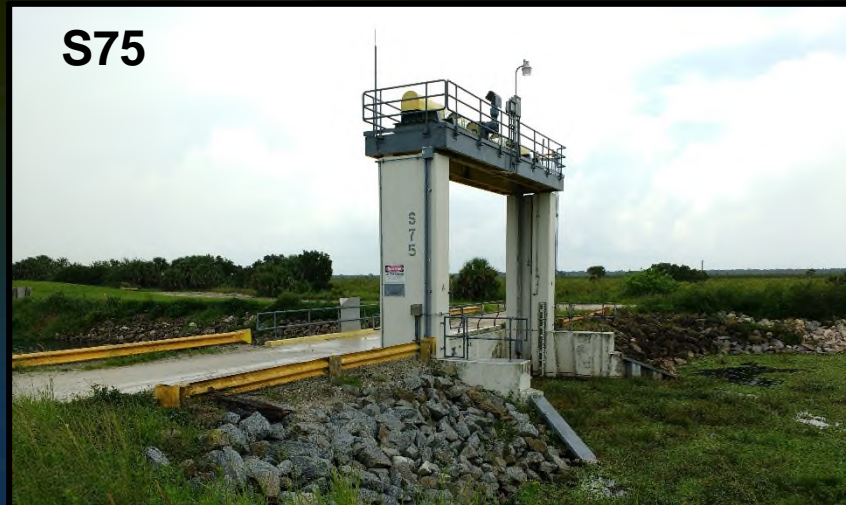
S75 Structure Details

- Built in 1960
- S75 structure is a reinforced concrete, gated spillway with discharge controlled by (10'x29') vertical lift gate.
- Design discharge capacity: 1150cfs

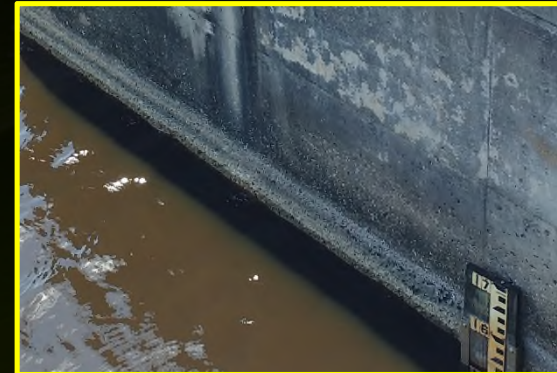
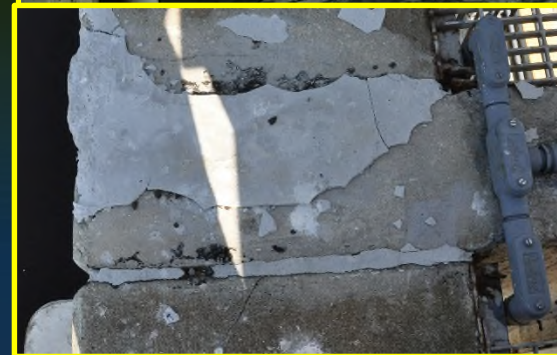
- Phased dewatering at S72 and full dewatering at S75
- Repair of eroded/spalled concrete
- Replacement of gates with stainless steel gates
- Recoating of wing walls
- Armoring weir crest, gate & needle beam recesses
- Installing / recoating handrails
- Replacing guardrails
- Adding new staff gauges and stilling wells
- New concrete approach to bridge deck
